Troubleshooting and maintenance

Troubleshooting common issues

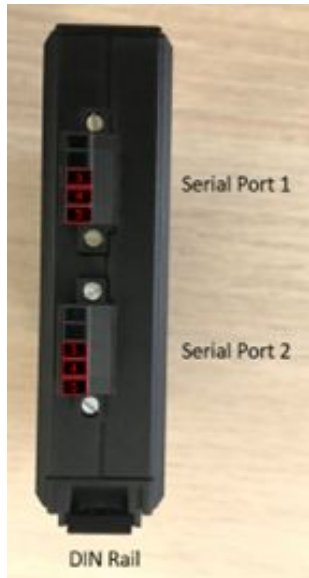
- For compatible RS-485 devices, connect them to either serial port 1 or 2 on the ePowerLog.

Pin	RS-232	RS-422	RS-485
1	TXD	TXD+	---
2	RXD	TXD-	---
3	RTS	RXD+	D+
4	CTS	RXD-	D-
5	GND	GND	GND

- that cables are properly inserted and securely fixed in the pins.
- That the cables are correctly stripped and that the sheathing is intact up to the pins.
- that the cable length does not exceed 1000 meters.

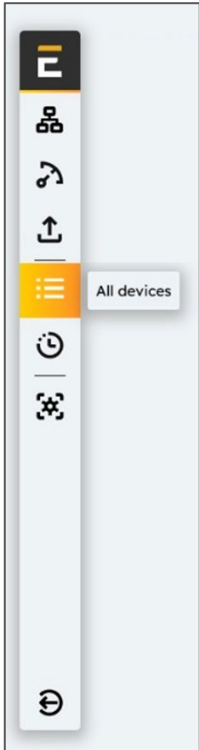
Status
Disconnected
Connected

⇒ Go to the **"All Devices"** tab on eConf to view the communication status of all components, including PV inverters, meters, genset controllers, and BESS.

- If any device appears as **"Disconnected"**, it may indicate incorrect RTU/TCP parameters or a configuration mismatch with Elum's products
- Verify RTU and TCP parameters:
 - **RTU parameters:** Cross-check the **Slave ID**, **Baud Rate**, and **Parity** on the **"Disconnected"** device with the settings in eConf.
 - **TCP parameters:** Ensure the device is on the same subnet as the Elum Explorer, avoiding IPs in the **192.168.4.XX** range. Verify that the subnet mask matches the one used by Elum Explorer.
