Troubleshooting and maintenance

Troubleshooting common issues

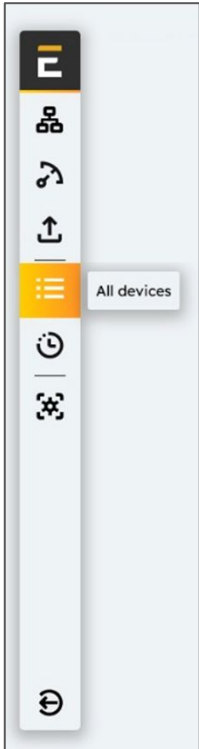
⇒ Go to the **"All Devices"** tab on eConf to view the communication status of all components, including PV inverters, meters, genset controllers, and BESS.

- If any device appears as **"Disconnected"**, it may indicate incorrect RTU/TCP parameters or a configuration mismatch with Elum's products
- Verify RTU and TCP parameters:
 - **RTU parameters:** Cross-check the **Slave ID**, **Baud Rate**, and **Parity** on the **"Disconnected"** device with the settings in eConf.
 - **TCP parameters:** Ensure the device is on the same subnet as the Elum Explorer, avoiding IPs in the **192.168.4.XX** range. Verify that the subnet mask matches the one used by Elum Explorer.

Status
Disconnected
Connected
