## Troubleshooting and maintenance

## 1) Unreachable

### Troubleshooting protocol for RTU communication :

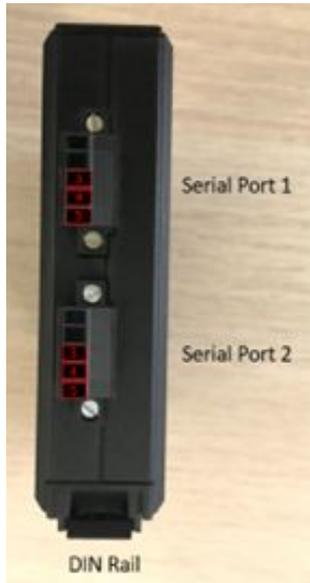
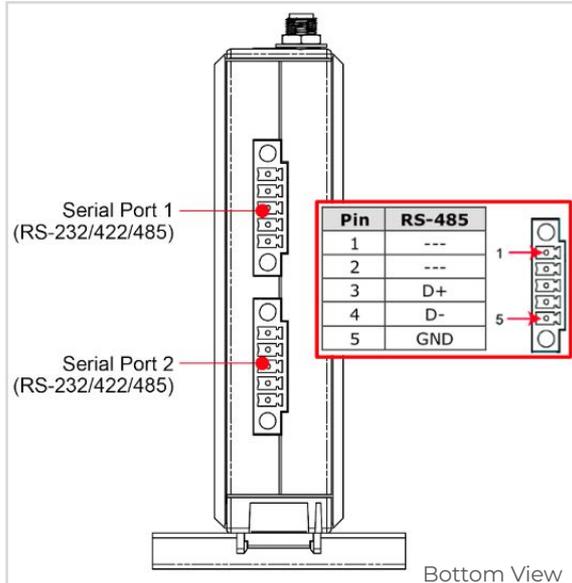
- For compatible RS-485 devices, connect them to either serial port 1 or 2 on the ePowerControl.

Pin	RS-232	RS-422	RS-485
1	TXD	TXD+	---
2	RXD	TXD-	---
3	RTS	RXD+	D+
4	CTS	RXD-	D-
5	GND	GND	GND

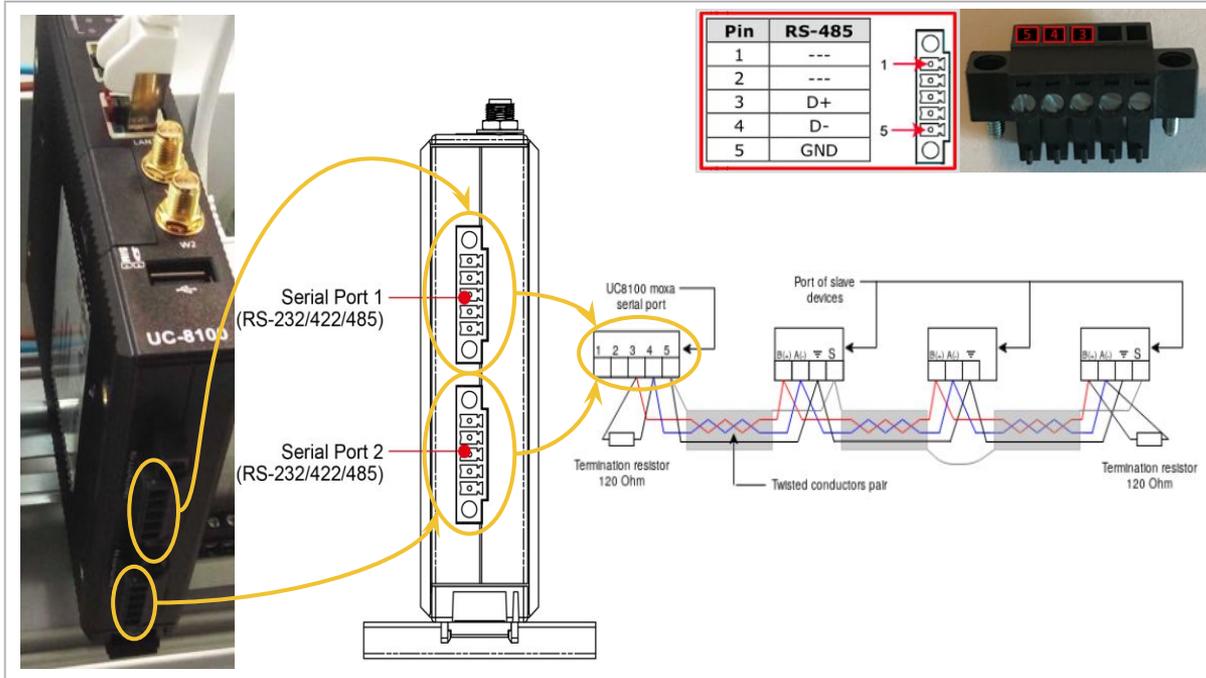
- 1) Ensure the cable used is a **shielded twisted pair**.
- 2) Verify that the **D(+)** and **D(-)** cables are from the **same twisted pair** and follow the pinout specified in the manufacturer's manual.
- 3) **Pin 3** of the serial port should be connected in a daisy chain to all the **DataB(+)** ports of the devices.
- 4) **Pin 4** of the serial port should be connected in a daisy chain to all the **DataA(-)** ports of the devices.
- 5) **Pin 5** of the serial port should be connected in a daisy chain to all the **GND** ports of the devices.

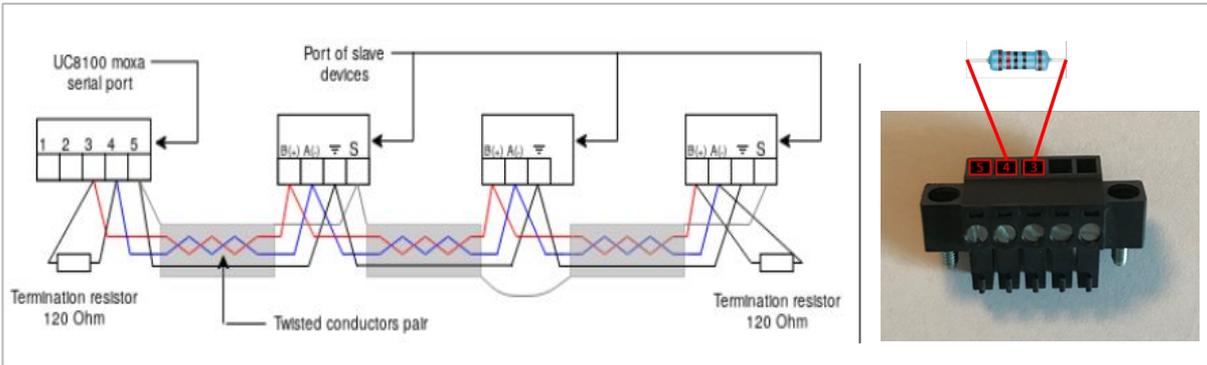
1) Make sure to connect the **termination resistors** between **DataB(+)** and **DataA(-)** (as shown in the figure). Ensure that the resistors match the impedance of the communication cable, typically **120 Ohms**.

2) Ensure the **shielding** is continuous across all serial lines and connects to the **GND** wire of the RS-485 circuit at the controller (**Pin 5**).

3) Confirm that the **shielding** is connected only at the controller level with the GND wire, as specified, to prevent ground loops.

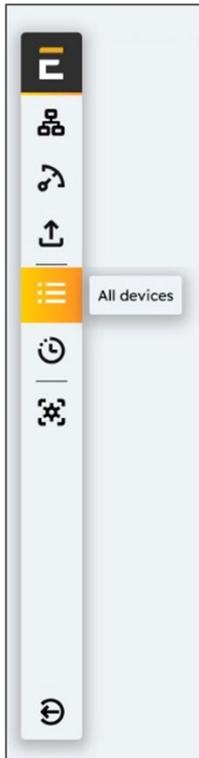
⇒ Go to the **"All Devices" tab** on eConf to view the communication status of all components, including PV inverters, meters, genset controllers, and BESS.

- If any device appears as **"Disconnected"**, it may indicate incorrect RTU/TCP parameters or a configuration mismatch with Elum's products
- Verify RTU and TCP parameters:
  - **RTU parameters:** Cross-check the **Slave ID**, **Baud Rate**, and **Parity** on the **"Disconnected"** device with the settings in eConf.
  - **TCP parameters:** Ensure the device is on the same subnet as the Elum Explorer, avoiding IPs in the **192.168.4.XX** range. Verify that the subnet mask matches the one used by Elum Explorer.

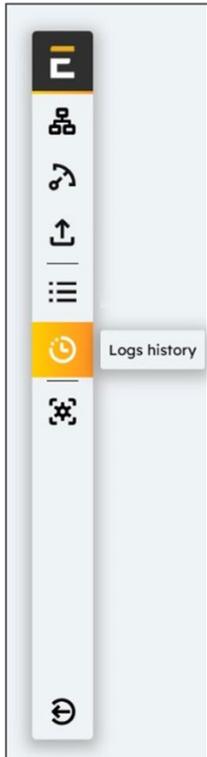
⇒ Go to the "**Logs**" tab on eConf to identify any unwanted disconnections affecting setpoints sent by Elum.

- Confirm that the correct driver (reference) is selected for the device.
- **Verify Baud Rate and character format:** Confirm that the device's baud rate and character format match the controller's configuration.
- **Ensure compliance with wiring guidelines:** Verify that the RS-485 wiring follows the guidelines discussed in the first point to avoid misconfigurations.
- **Check shielding integrity:**
  - **Inspect wire labeling:** Verify that the wire meets recommended specifications for capacitance, resistance, and conductor count.
  - **Grounding of shield:** Ensure the shield is grounded at only one point on the RS-485 chain and maintains continuity across the entire daisy chain.

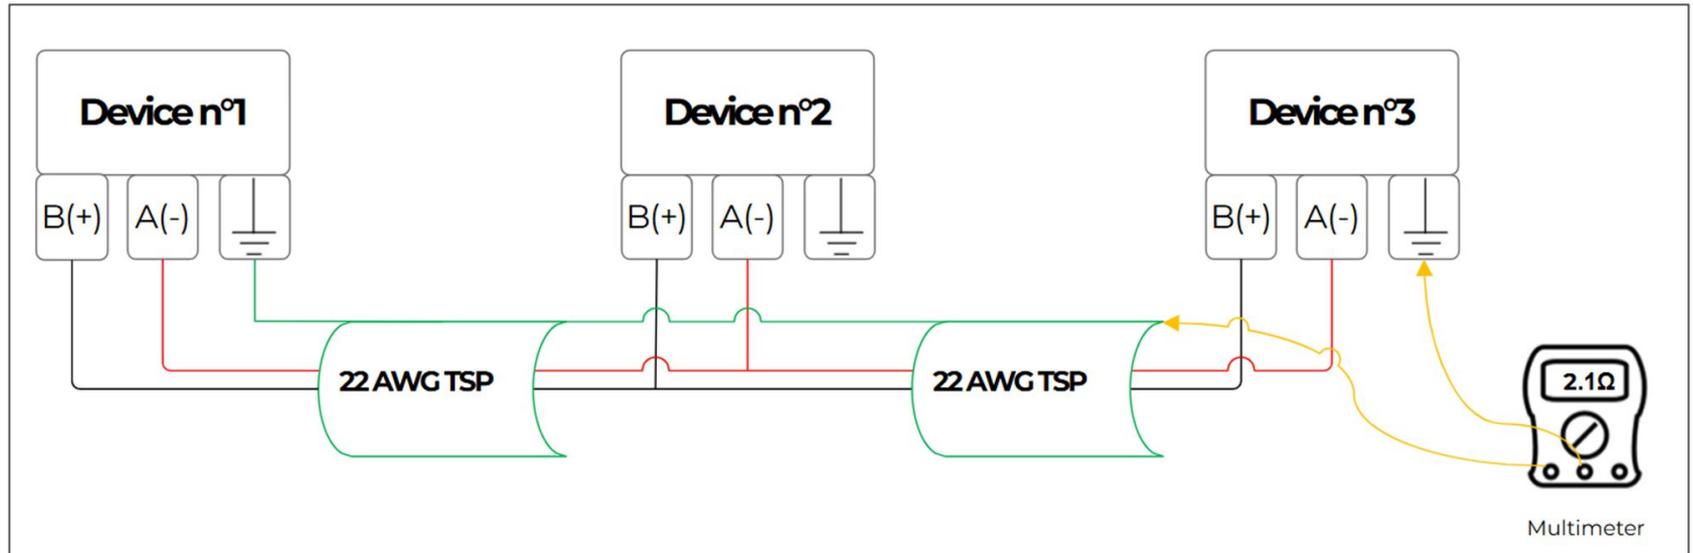
- ⇒ **Test shield continuity:** Using a multimeter, test the continuity between the shield and earth ground, starting from the ungrounded end, to confirm proper grounding setup. The point here is to read a very low resistance, as shown in the following diagram.

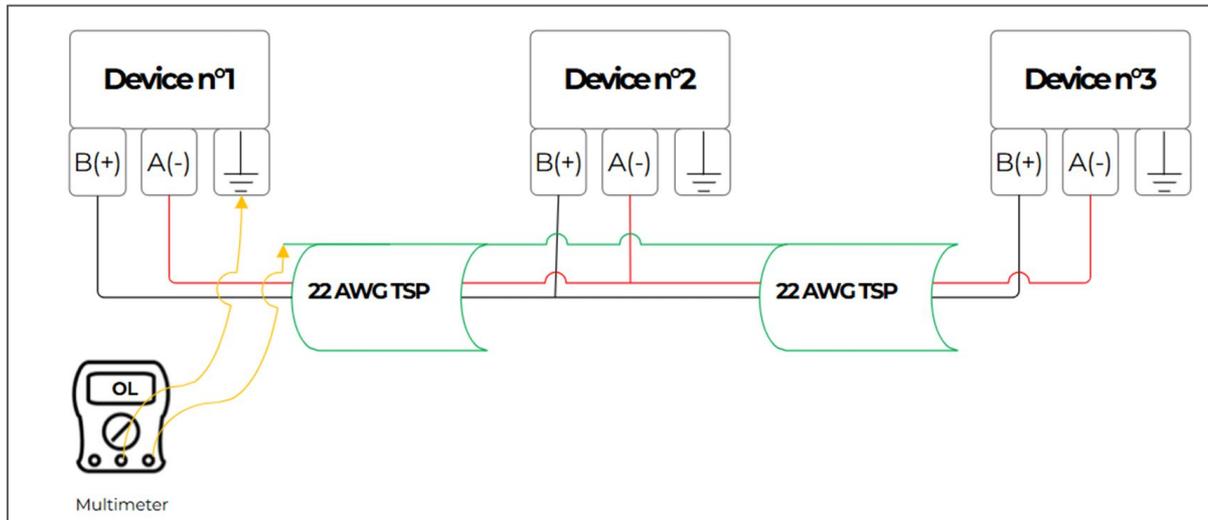
⇒ **Test shield continuity:** At the opposite end of the daisy chain, check that the shield is physically connected to the ground. Perform the same test, but this time disconnect the shield wire from its ground connection. When tested with a multimeter, it should read as an open circuit to earth ground, as shown in the following diagram.

If "OL" (open load) doesn't appear, multiple grounding points may exist. Ensure only the shield's start is grounded. Then, reconnect it to ground at the first device only.

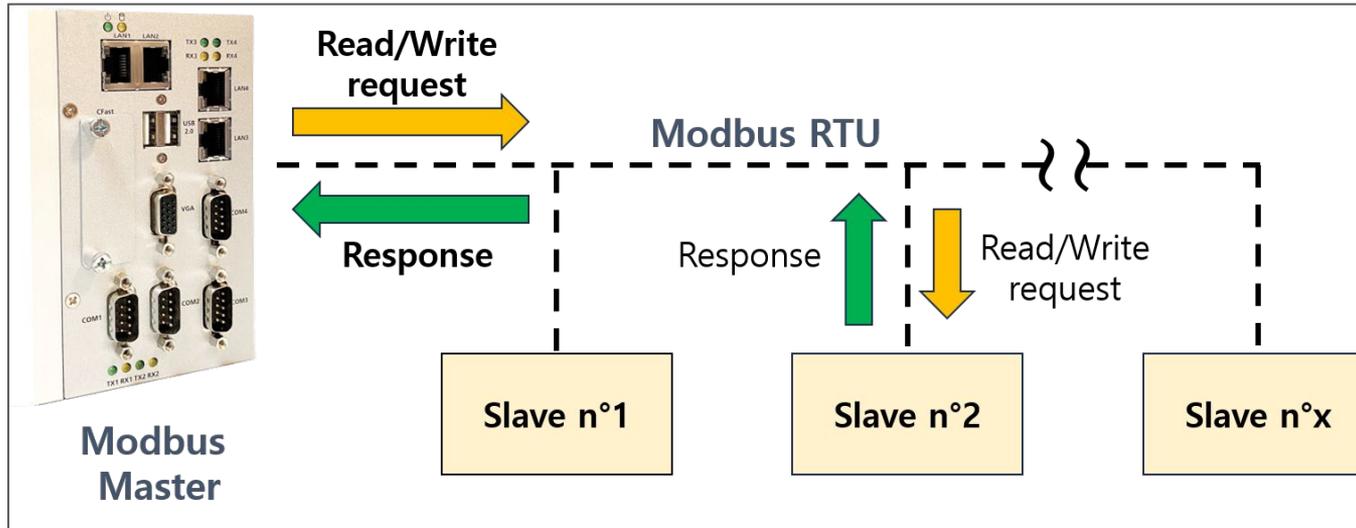
In a network, each slave device has a unique address. When the master sends a data request, it includes the slave's address as the first piece of information. This allows each slave to recognize immediately if the message is meant for them or if they should ignore it.

⇒ Ensure there is only one master device, typically the ePowerControl ZE3000 unit, on the line.
