Troubleshooting and maintenance

Troubleshooting common issues

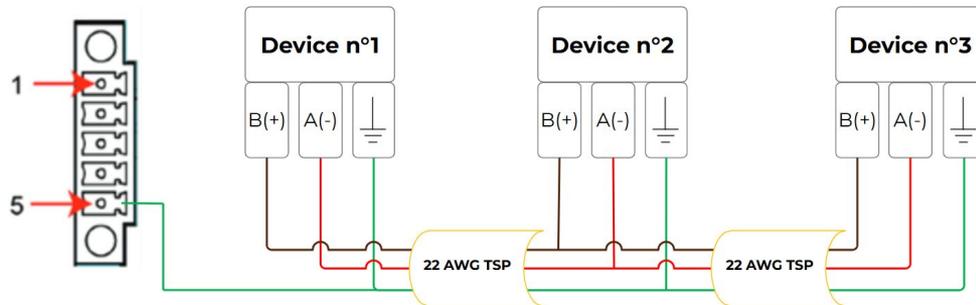
- 1) Make sure to connect the **termination resistors** between **DataB(+)** and **DataA(-)** (as shown in the figure). Ensure that the resistors match the impedance of the communication cable, typically **120 Ohms**.
- 2) Ensure the **shielding** is continuous across all serial lines and connects to the **GND** wire of the RS-485 circuit at the controller (**Pin 5**).
- 3) Confirm that the **shielding** is connected only at the controller level with the GND wire, as specified, to prevent ground loops.

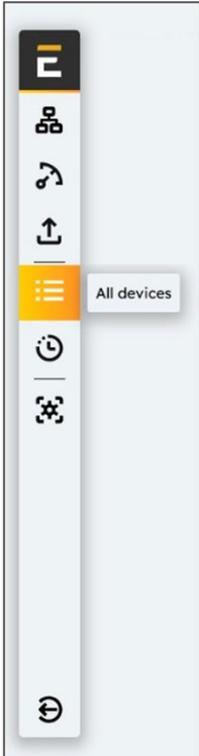
Status
Disconnected
Connected

⇒ Go to the **"All Devices"** tab on eConf to view the communication status of all components, including PV inverters, meters, genset controllers, and BESS.

- If any device appears as **"Disconnected"**, it may indicate incorrect RTU/TCP parameters or a configuration mismatch with Elum's products
- Verify RTU and TCP parameters:
 - **RTU parameters:** Cross-check the Slave ID, Baud Rate, and Parity on the **"Disconnected"** device with the settings in eConf.
 - **TCP parameters:** Ensure the device is on the same subnet as the Elum Explorer, avoiding IPs in the **192.168.4.XX** range. Verify that the subnet mask matches the one used by Elum Explorer.

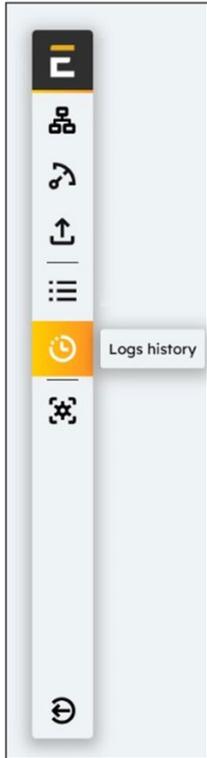
⇒ Go to the "**Logs**" tab on eConf to identify any unwanted disconnections affecting setpoints sent by Elum.

- Confirm that the correct driver (reference) is selected for the device.
- **Verify Baud Rate and character format:** Confirm that the device's baud rate and character format match the controller's configuration.
- **Ensure compliance with wiring guidelines:** Verify that the RS-485 wiring follows the guidelines discussed in the first point to avoid misconfigurations.
- **Check shielding integrity:**
 - **Inspect wire labeling:** Verify that the wire meets recommended specifications for capacitance, resistance, and conductor count.
 - **Grounding of shield:** Ensure the shield is grounded at only one point on the RS-485 chain and maintains continuity across the entire daisy chain.

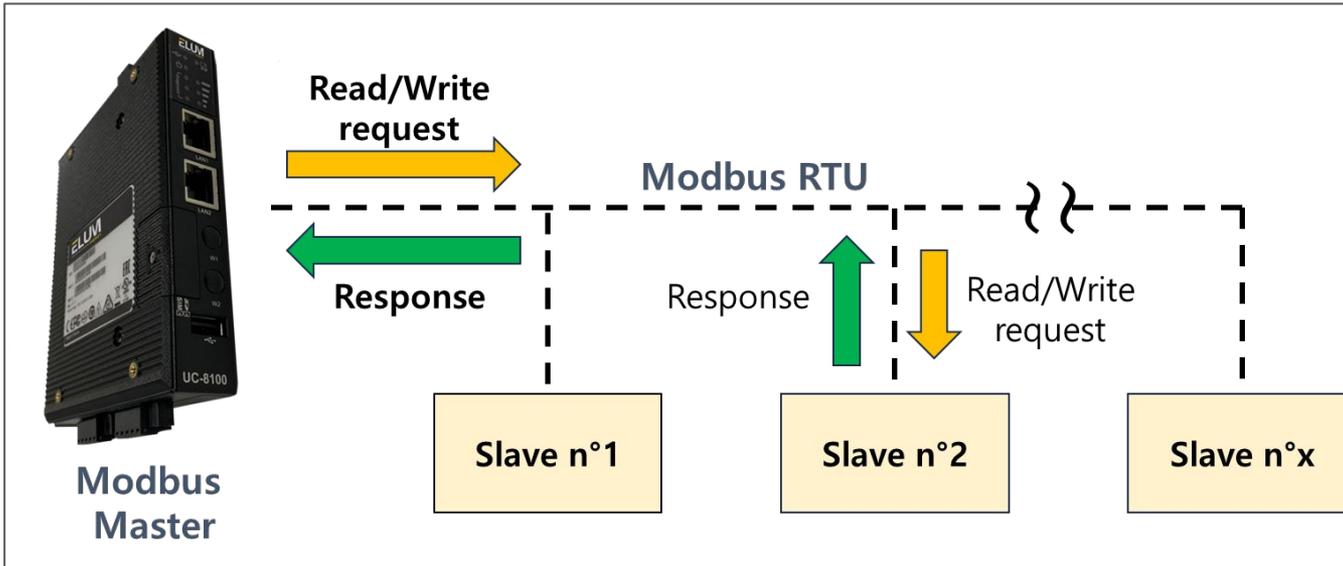
In a network, each slave device has a unique address. When the master sends a data request, it includes the slave's address as the first piece of information. This allows each slave to recognize immediately if the message is meant for them or if they should ignore it.

⇒ Ensure there is only one master device, typically the ePowerControl ZE unit, on the line.
